GEOTEX® REPORT

A Geotextile Case Study From SI® Geosolutions

Geotex® Tubes Used to Dewater Tannery Sludge

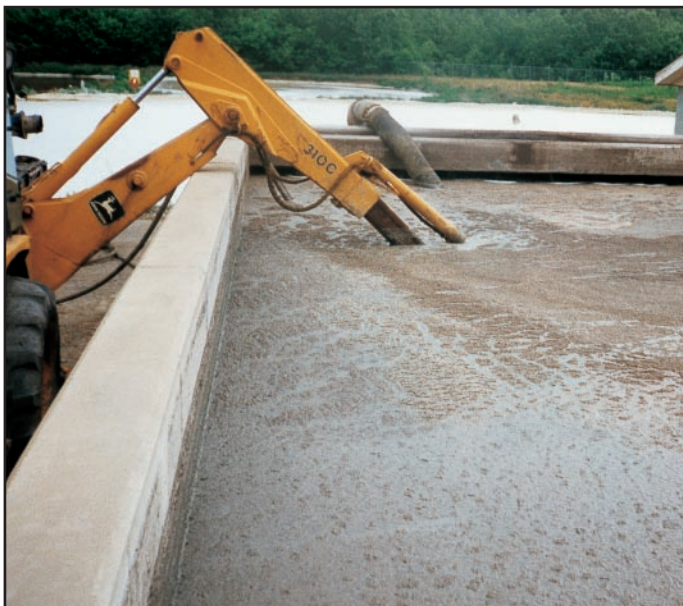
Tannery Sludge before dewatering

A Mid-Atlantic tannery was faced with a critical decision when production outpaced the capacity of its wastewater treatment system. Sludge, the waste product of the tanning process, had built up over time and was continuing to accumulate. Fines from the state environmental agency, odor complaints from area citizens and the looming threat of being shut down plagued tannery management. So, why did the tannery not simply haul the sludge to the dump? Sludge will not be accepted at a landfill unless it has been dewatered to an acceptable solids level. The typical method of dewatering sludge is to use settling tanks and filter presses. This process can only treat small amounts of waste at a time; therefore, the method was not sufficient for the volume required to be removed.

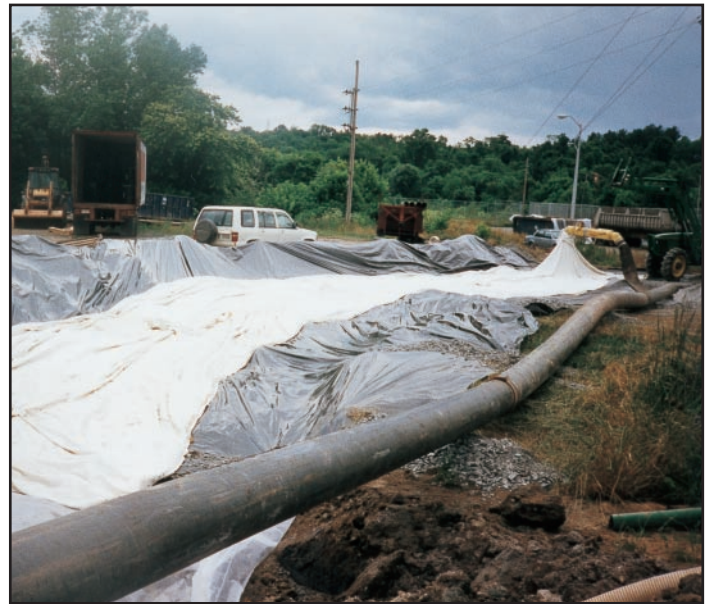
Empty GEOTEX® Tubes are spread throughout graded area in preparation for filling.

The dewatering site was prepared by grading a 125' X 75' area and lining it with an impermeable plastic sheet. Water draining from the tubes during dewatering was to flow into a sump to be pumped back into the waste collection system. Five different tubes were used. A small polypropylene tube, fabricated 15 feet in circumference and 40 feet in length and 4 high strength polyester tubes, fabricated 30 feet in circumference and ranging in length from 40 to 200 feet. The polypropylene tube was made from Geotex 4X6 and the polyester tubes were made from Geotex 12X12 and Geotex 10X10. As the tubes were filled, the geotextile tightened due to the pressure and spaces between the weave became smaller; as a result, even extremely small-sized solids were prevented from escaping. Two types of dewatering occurred during the process. Initially, dewatering was mechanical due to pumping, and then passive dewatering followed over a period of weeks.

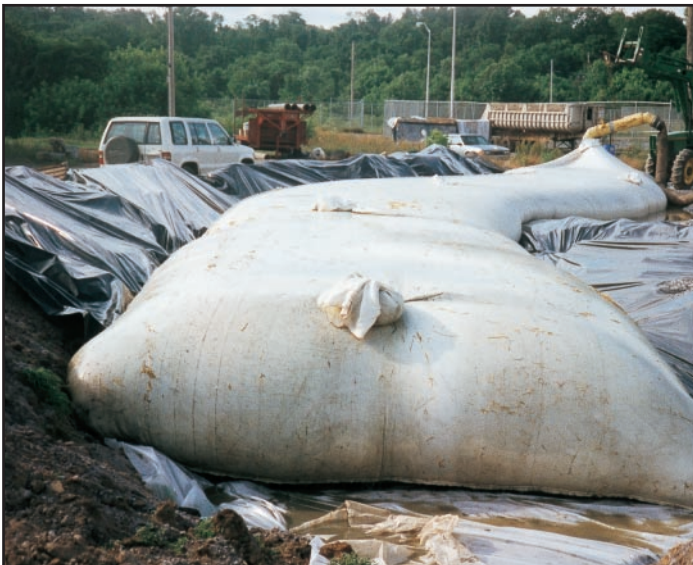
Tannery sludge is pumped from the holding tank into GEOTEX® Tubes.

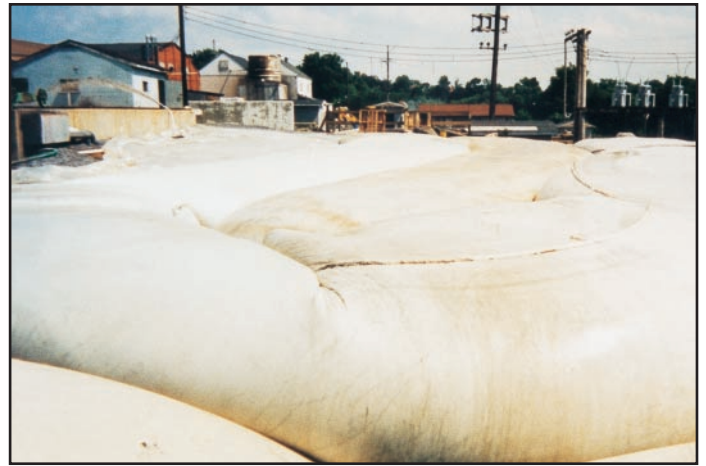
Water filters from tannery sludge.

A sample of sludge pumped into a tube, tested by Hera Tech Inc., had a Total Suspended Solids (TSS) of 441 grams/liter. Water leaving the tube had a TSS of 0.65 grams/liter. This indicates that 99.998% of the solids pumped into the tube was retained. Chromium within the sludge was reduced from 3.370 mg/l pre-tube to 0.8437 mg/l post-tube. After two weeks, the primary sludge had reached a percent solid greater than 25% while the biological sludge varied between 18 and 30%. The landfill requires sludge to be at a solids level greater than 17%; therefore, the sludge was ready to be excavated from the tubes.
